NINTH INTERIM REPORT OF THE SPECIAL DEPUTY RECEIVER
FOR GALILEE MEMORIAL GARDENS

Ground Penetrating Radar Systems, Inc.
Detailed Report
Galilee Memorial Gardens Cemetery Scan
March 2016

Re: GPR Report of Investigation and Survey for Occupied and Un-occupied Burial Sites
Site Location: Galilee Memorial Gardens, Bartlett, TN
Date of Inspection: Feb 11 thru March 15, 2016

RE: GALILEE MEMORIAL GARDENS
RESULT OF RE-EVALUATION AND GPR SCANNING

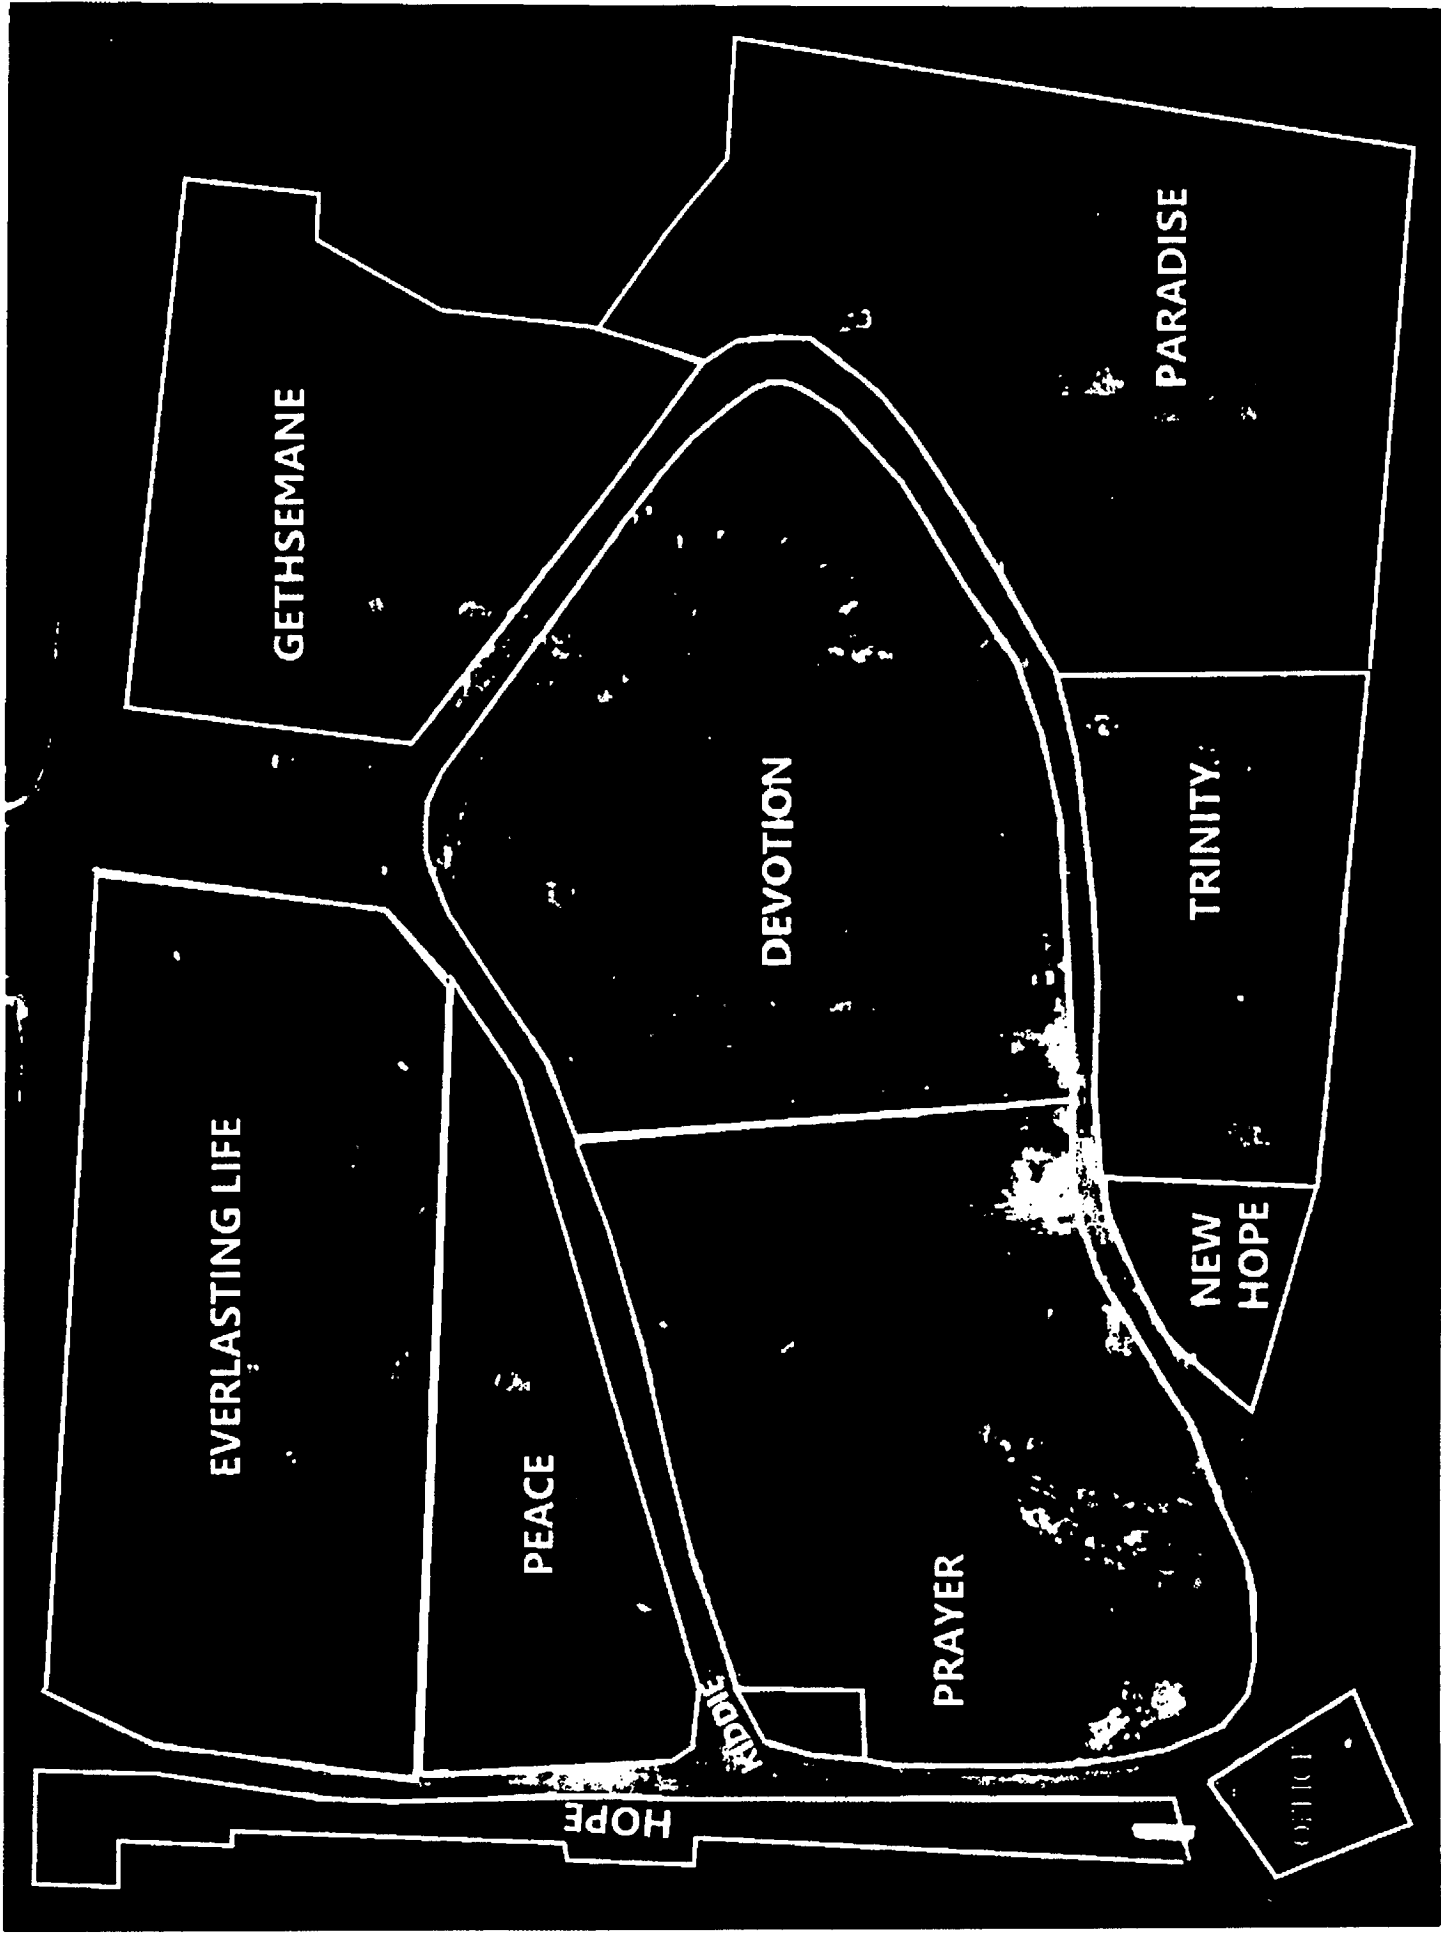
Exhibit D

Updated Google Earth Scan Of GMG.pdf

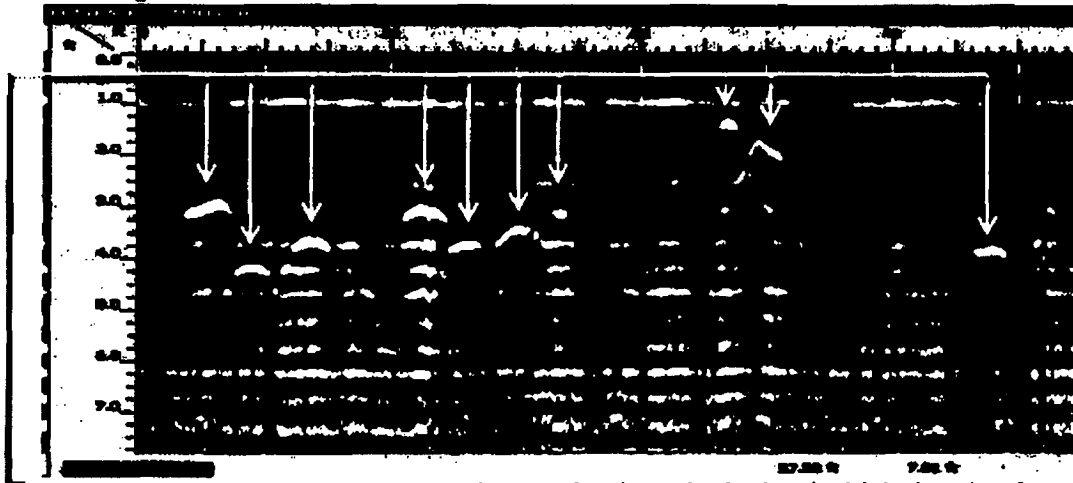
Data Image 1

Each of the anomalies pictured represent what GPRS has determined to be a burial site based on GPR data. The depth scale on the left indicates burial depth (to top of coffin). The distance scale at the top of the image can be used to measure spacing.

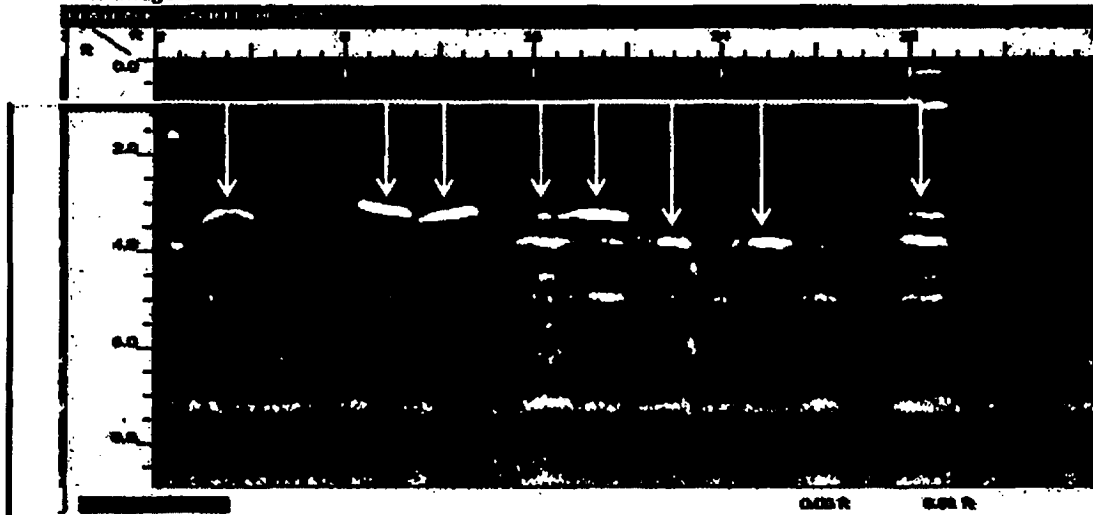
Data Image 2

This data shows a great representation of a row of burials at approx. 3' deep. Some of these burials were placed within inches of each other.

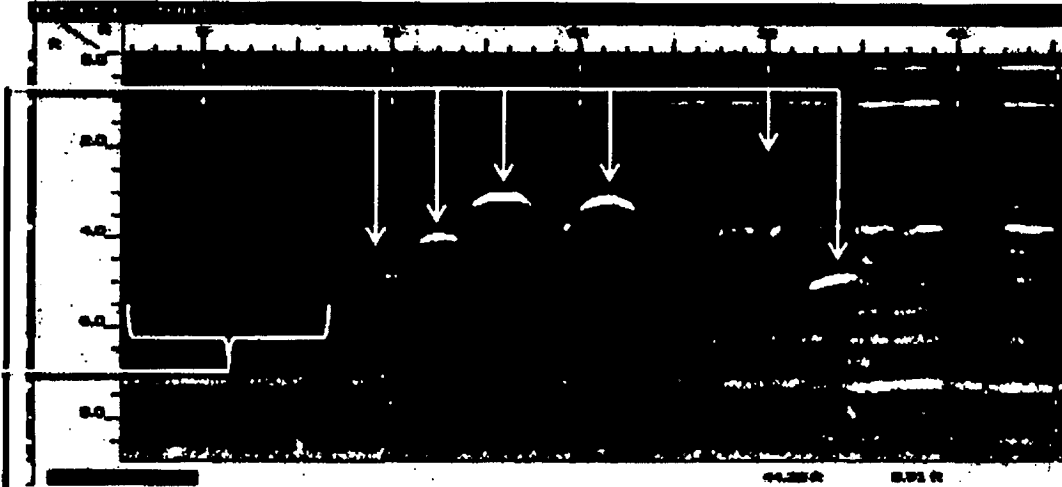
Data Image 3

These anomalies aren't as pronounced as the others from surrounding areas. We suspect reduced data quality here was due to fill dirt.

This image is representative of the areas that are suspected to have been built up with fill dirt. The raised topography of the land posed issues for data quality due to possible clay content in fill dirt.

There were multiple headstones marking gravesites through this stretch, but we were not able to detect any conclusive burial sites.

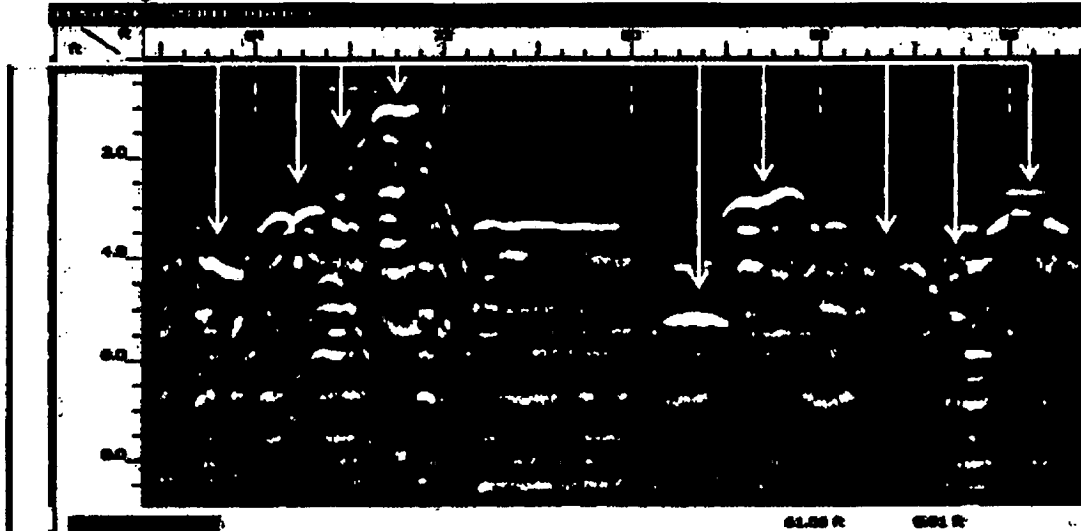
Data Image 4

In this image, we get very pronounced anomalies indicating burials. Some burials were found as shallow as 6".

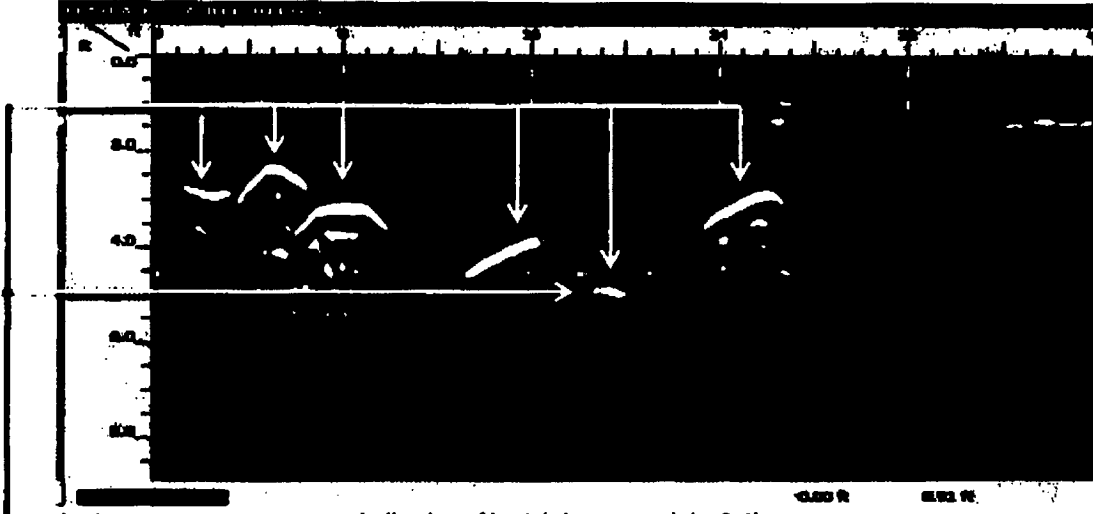
Data Image 5

Again, we can see very strong indication of burial sites around the 3-4' range.

As we look past 4' in depth, the signal quality reduces and we do not get as strong of image.

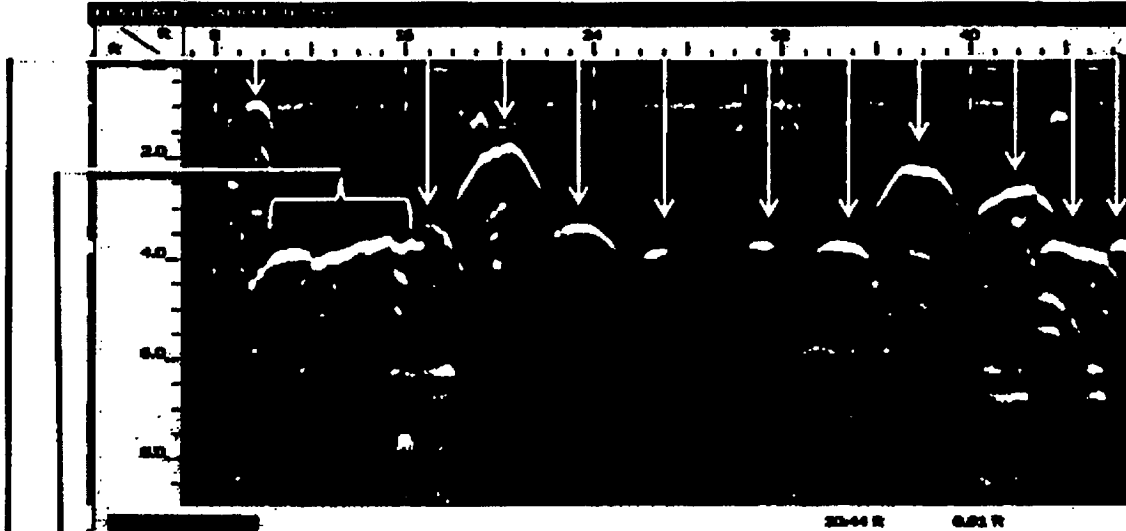
Data Image 6

This image shows an example of potential "stacking" of grave sites. There is NO space between anomalies. There may be coffins below these anomalies that GPR cannot detect.

Other burials in this image are fairly evenly spaced.

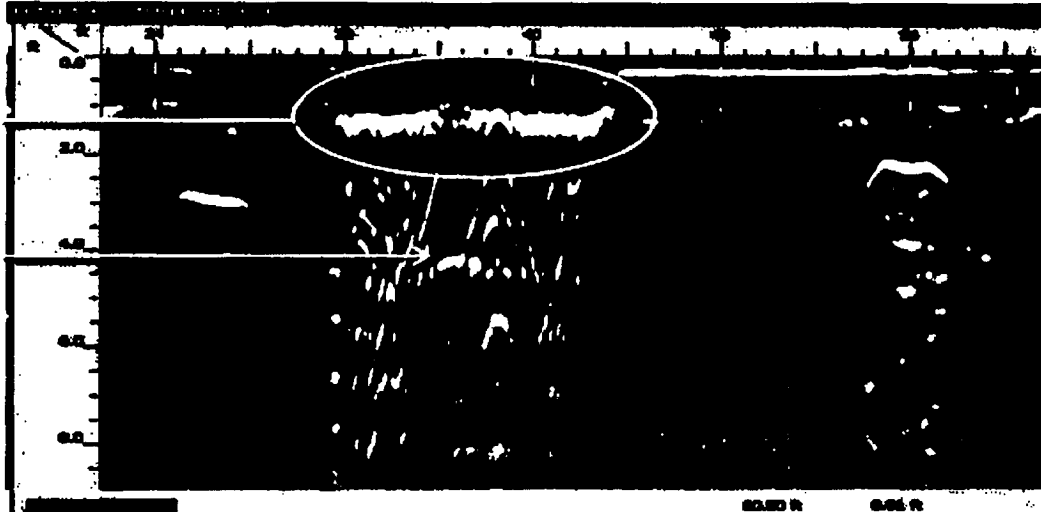
Data Image 7

This image was collected while scanning through standing water. With saturated soils, we are not able to consistently recover conclusive data indicating a burial site.

In this scan, we were able detect an anomaly in the saturated soil. This is unusual and inconsistent.

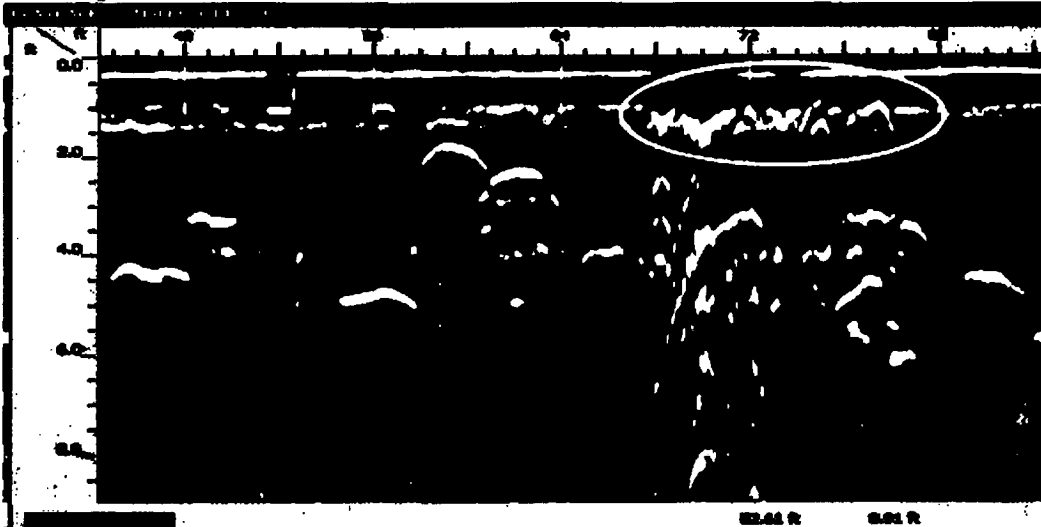
Data Image 8

Circled, is another area of saturated soil. Again, we can make out at least two anomalies, but our confidence compared to the readings on the left half of the screen, is greatly reduced.

Over multiple trips back to Galilee Memorial, we were able to go back and cover many of these areas after they had dried.
